Southwest Windpower Whisper 175

The Whisper 175, the only 2-bladed machine at the site, was installed during a Southwest Windpower installation workshop on October 18-21, 2004. Josh Levinson and Jay Yeager of Southwest Windpower traveled from Arizona to lead the 4-day, hands-on workshop.

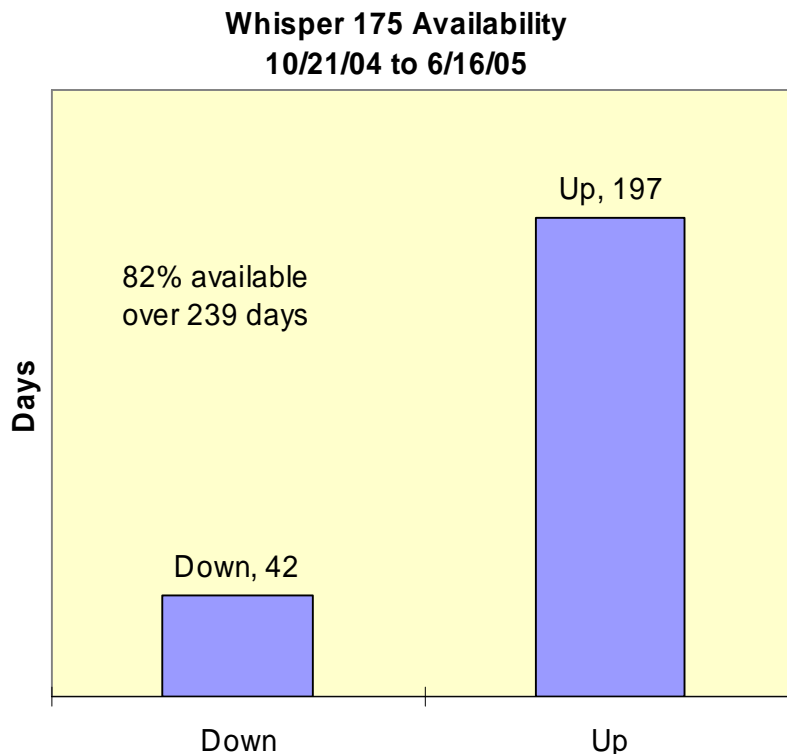
Table 1 Failures and repairs for the Whisper 175

From the 10/21/04 installation until the 6/16/05 decommissioning, the Whisper 175 has been available 82% of the time. Three periods of downtime were experienced, all due to wiring failures. Replacement parts were covered under warranty. All repairs were performed onsite by SWI personnel.

Failure		Repair	
12/3/04	Short in tail light circuit	12/17/04	Removed light circuit, tightened J-box
3/17/05	Brush card short	4/8/05	Soldering attempt failed; new brush card assembly installed
6/12/05	Brush card short	6/16/05	Decommissioned; making room for new Whisper 500; repaired machine crated up

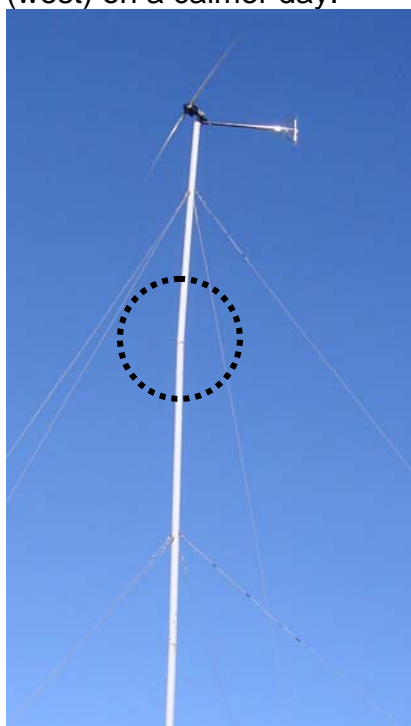
Previously noted kink at 2nd union is more noticeable. Should try to tighten top guy (west) on a calmer day.

11/5/04 Tower kink developed at a coupler

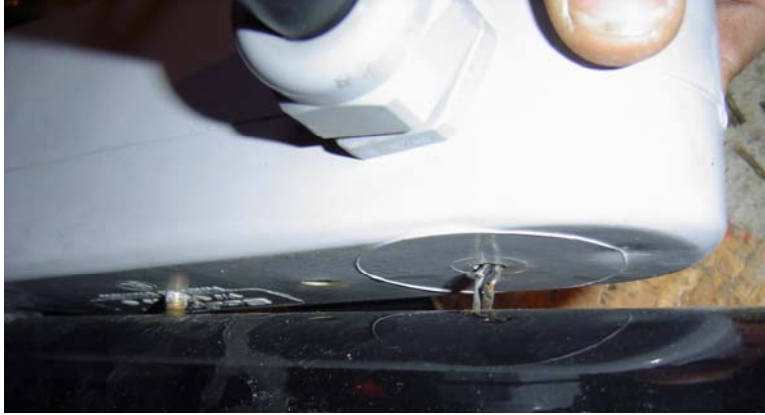
Took down the machine. Turbine removed from tower and inspected. Discovered that small wires from the LED running light were worn and shorting to the turbine chassis – MD

12/8/04 Shorted light wires

Repaired 175 (disconnected the light and re-assembled), erected with Adam & Ernie. Looks good. Adjusted guys some. Locked turnbuckles with wire. –BS

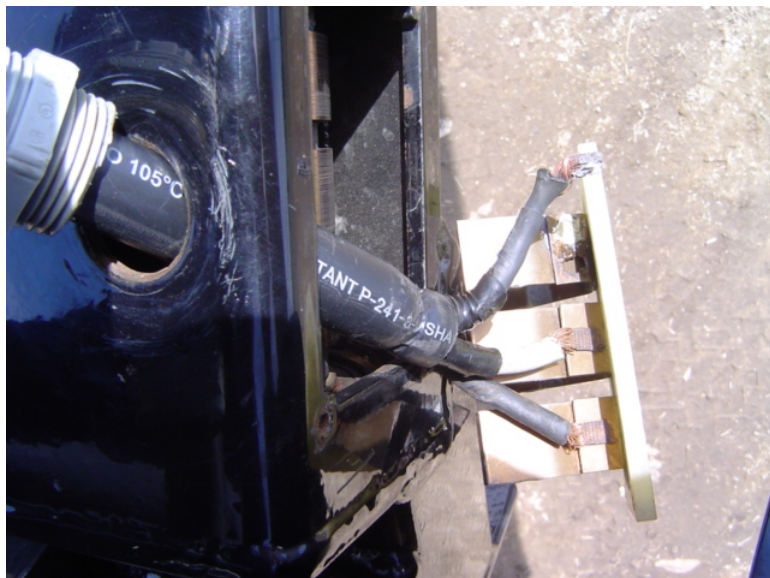
Lowered. Green wire disconnected from brush again. Need a new brush card.

4/6/05 Green wire repaired but attachment to brush card did not hold

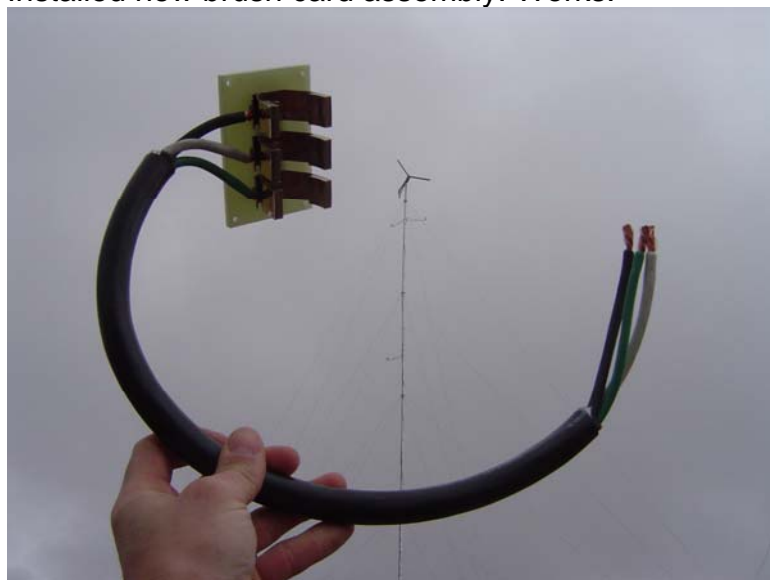
4/8/05 New brush card assembly

Installed new brush card assembly. Works.

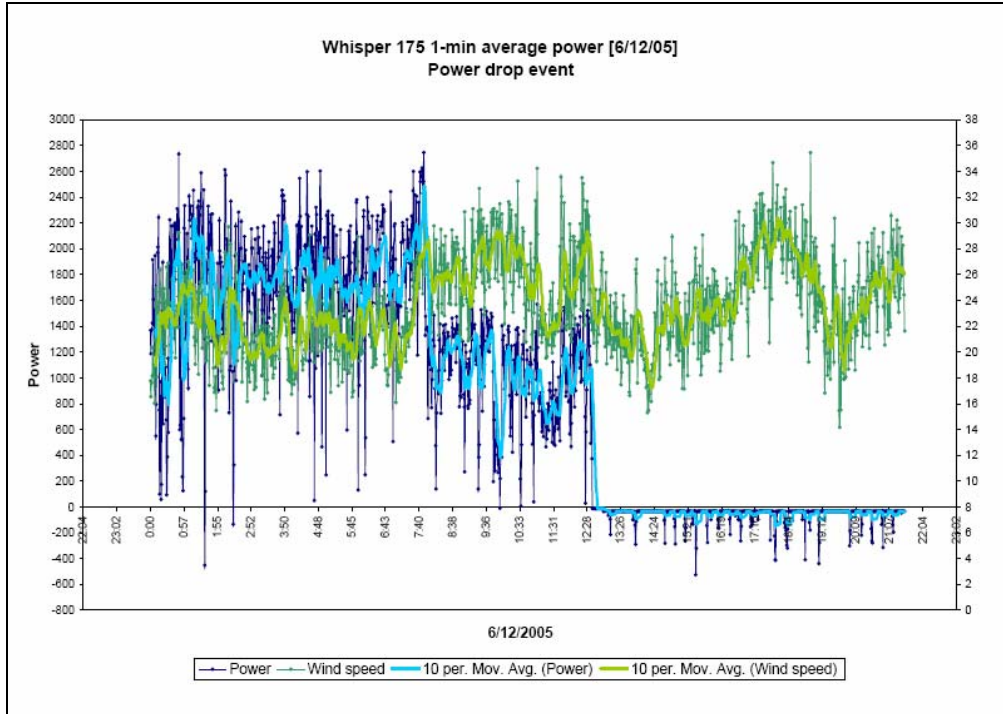
175 not running. Looks shorted.

6/12/05 Power and windspeed data showing the failure

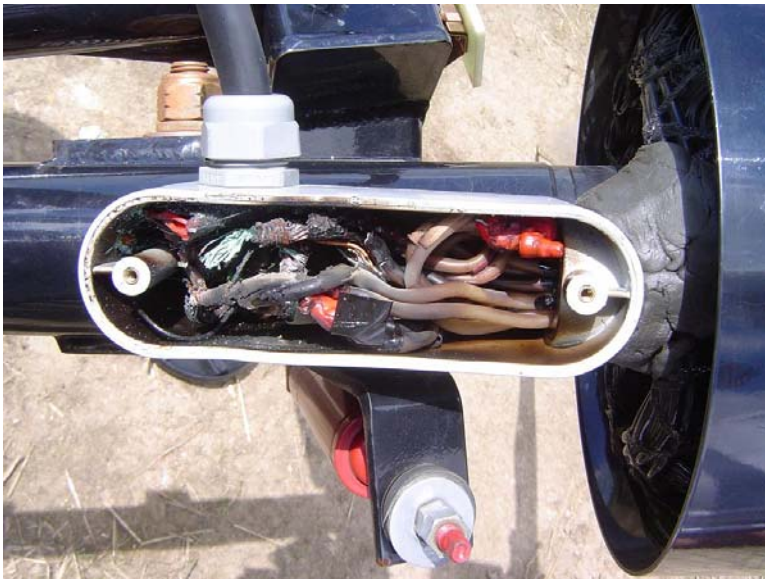
Lowered 175 with Dr. Raichle's class. Found wires in the junction box had shorted out and gotten quite hot. Called Jay at SWWP. He will send new brush card assembly. He recommends soldering and shrink tubing the wire connections.

6/16/05 Short in junction box

The latest short in the junction box resulted in a loss of wire identification from the alternator. The 12 field wires needed to be identified, grouped, and reconnected to the down-tower wires. It was necessary for this repair to be done at the SWWP factory. This was the end of the 175. It was repaired, sent back to us, and crated up. The replacement is a new product from SWWP, the Whisper 500 HV (high voltage) with a new Magnetek grid-tie system.
