Southwest Windpower Whisper H40/Whisper 100

S/N: 04343682

Activity Log

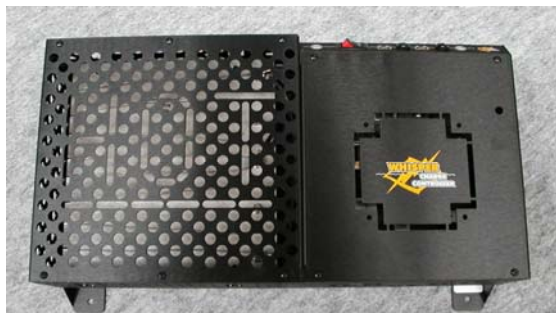
Disconnected turbine wired one at a time. Took off middle wire and it started up..shorted diode. Called Jay, he will send new controller.

12/15/04 New controller installed

Installed new H40 controller

LDC display plugged in, grounds connected, battery + and -, after confirming polarity with multimeter, connected turbine wires. Turned ON with green light on. Wind speed 15mph, 2.6A, 150W, 50.8V –BS

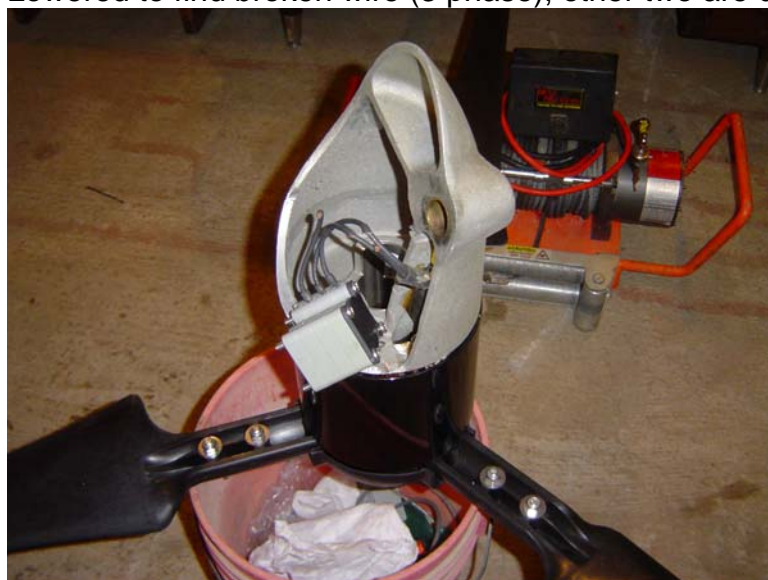
Noticed H40 making loud noise and producing about 50% power.

Lowered to find broken wire (3 phase), other two are damaged.

3/4/05 Turbine wires cut by casting

The new machine has a redesigned casting to prevent sticking in furl and wire damage as well as other improvement.

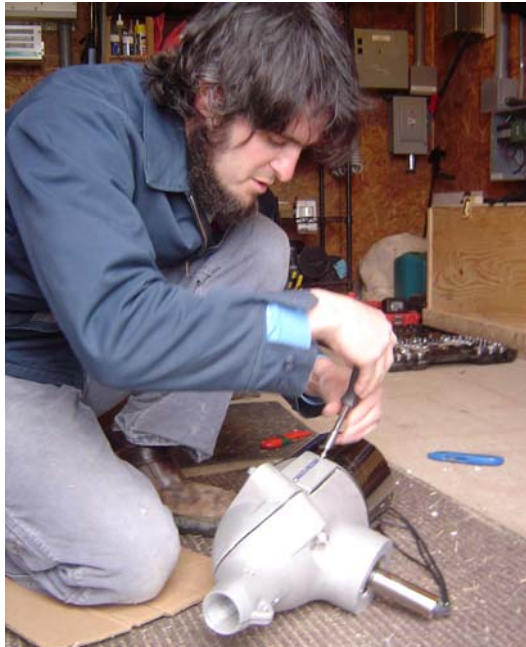
Installed (almost) bolts not screwing into threaded holes in head.

4/8/05 New Whisper 100

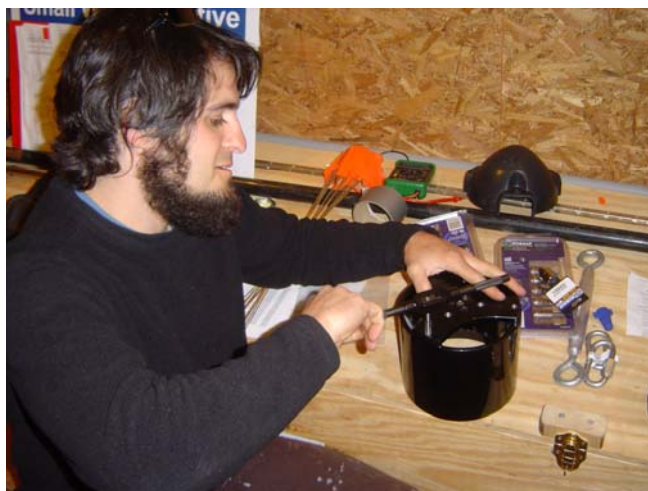
4/15/05 Chasing threads in new Whisper 100 head

Worked on bolts/holes

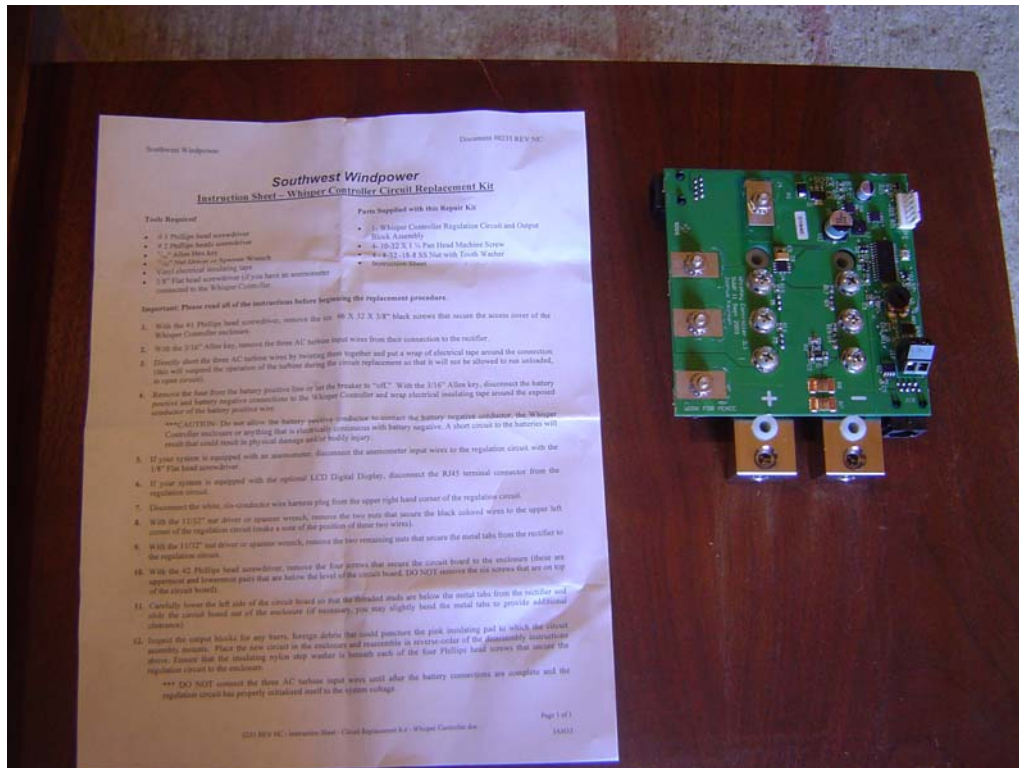
Controller is bad

Looked back at data, controller failed at 12:26am on 7/4/05

7/23/05 New Whisper 100 board installed

Installed replacement board in Whisper 100 controller
