## Bergey Wind Power XL.1

The Bergey XL.1 was installed by the SWI crew on July 15, 2004.

The 105-foot NRG tower and the 1kW, 24VDC battery-charging turbine were installed per the manufacturer's recommendations. A combination of screw-in augers and arrowhead anchors were used. The tower came complete with pipe.

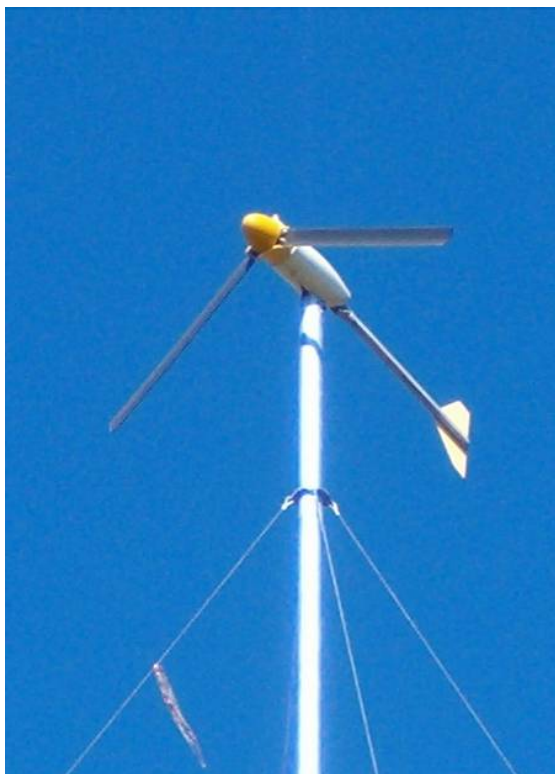
**9/22/04** Bergey missing a blade after Ivan

Machine put back up

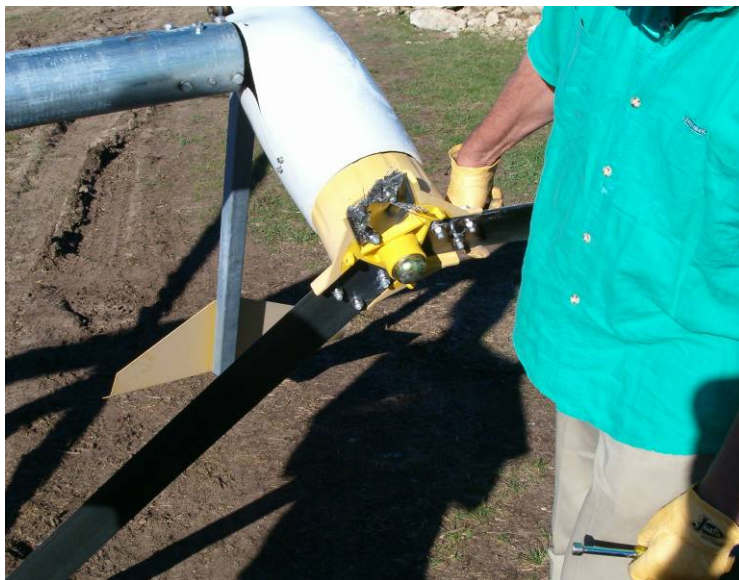
10/4/04 Investigating hurricane damage, broken blade

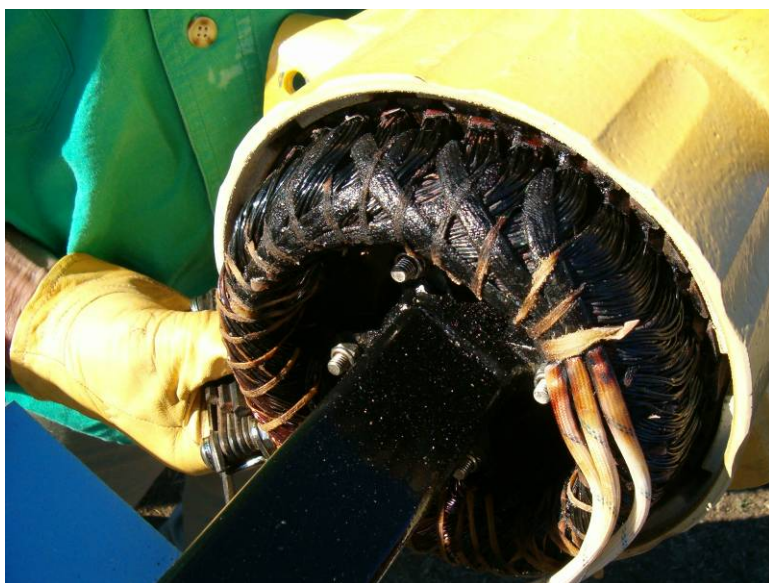
10/4/04 Hurricane damage, burned alternator

*The XL.1 was left in a shorted out state during the Hurricane. In retrospect, the machine would have had a better chance of survival if left in the freewheeling state.*

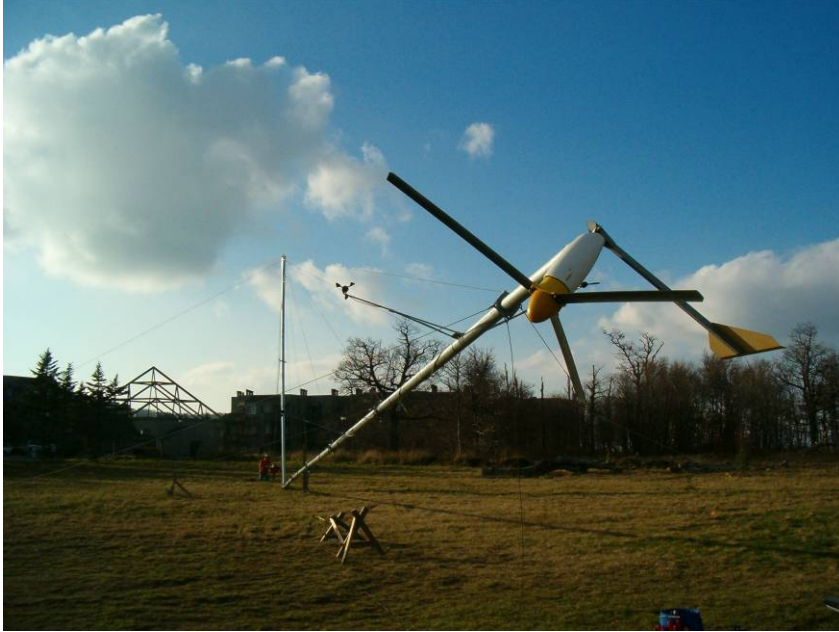
**11/1/04** Machine going back up after repairs

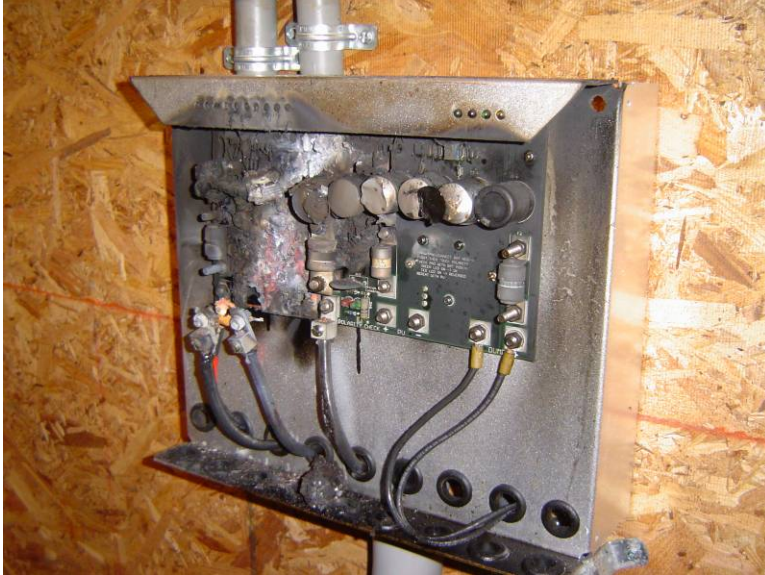
Last night, the controller burned up. The room was filled with smoke and stink. Steve Wilke recommended leaving it going unloaded but it will be loud. Took some pix to send.

**12/9/04** Burned controller

New controller installed. Batt – first, check polarity, batt +, wind -, check polarity, wind +, batt lights on, wind too light to start turbine. This controller is equipped with a 60A DC breaker.

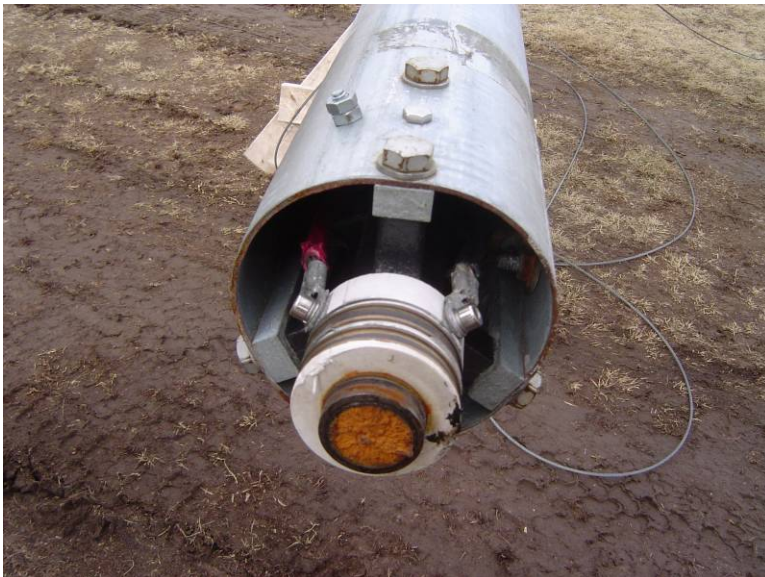
Arrived to photo the Bergey which had broken at the yaw shaft over Xmas and fell to the ground. (12/22-24)

**1/12/04** Broken yaw shaft. The landing left a nice dent on the ground.

Lowered tower, installed new turbine with larger yawshaft and properly sized adapter (no need for our shims). Help from Raichle's RE class. Raised tower.
